# Manhole Inspection Summary

Manhole # S19W\_\_023MH

Insp Date: **6/27/08 10:43 AM**

**Location** Address: **1609 spence st**

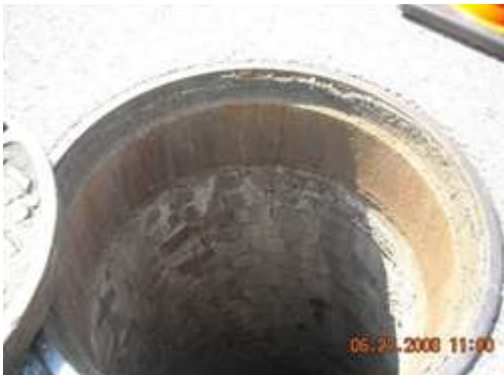
Sheeting Evidence

☐ Prev. Rehab Weather: **Dry** Subject To Ponding: **Sheeting**

inflow evidence from sheeting

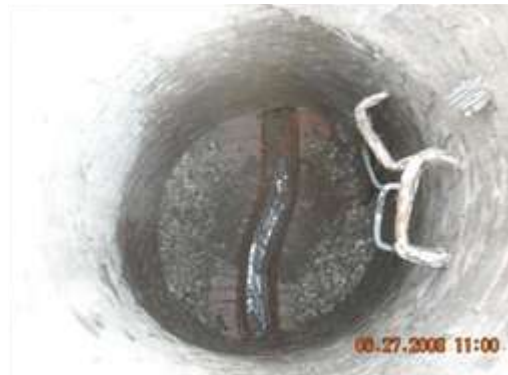
misc

bench debris

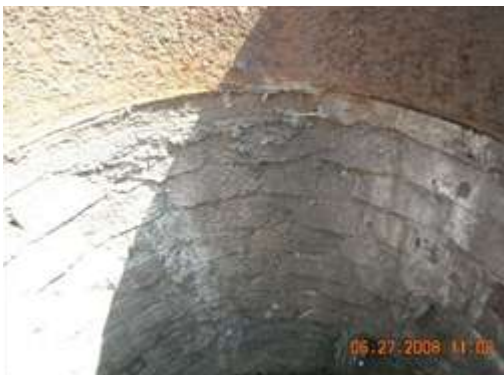
Defect 2

Condition: ☐ Sound ☒ **Cracked** ☐ Root Intrusion ☐ Loose Brick ☐ Deteriorated

Infiltration: ☐ None ☒ **Joint** ☐ Cracks ☐ Mortar ☐ Roots ☐ Wall

infiltration @ chimney joint, crack in chimney

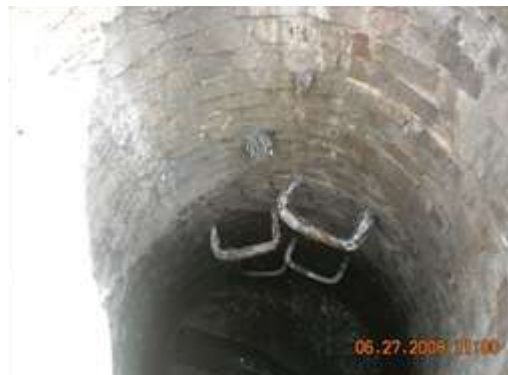
Defect 1

**Steps** Count: **4** Missing: **2** ☒ **Corroded**

corroded & missing steps

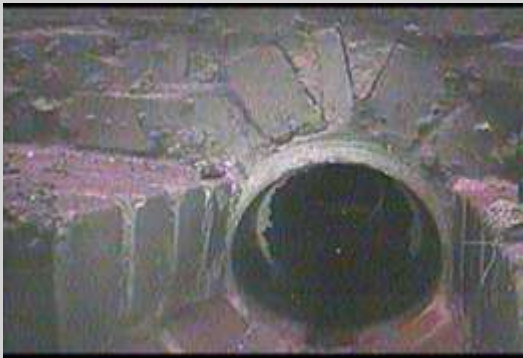
12 O'Clock Outflow

Pipe Height: **8.4** (in.) Rod and Bar (Angled)  
Pipe Material: **Clay** ☐ Pipe Lined  
Invert Depth: **10.00** (ft.) Flow Characteristics: **Slow**  
Deposits: ☒ None ☐ Mud ☐ Sludge ☐ Debris ☐ Grease  
Silt Depth: **0** (in.) Deposits Extent:  
Infiltration: **None** Pipe Seal Cond: **Sound**

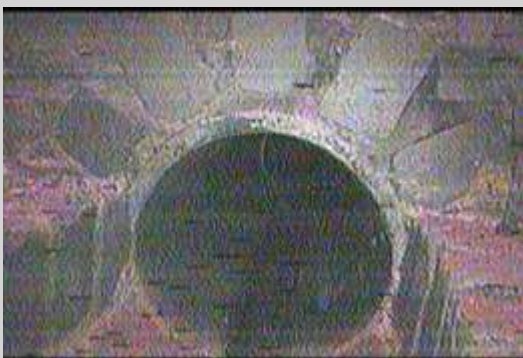
6 O'Clock Inflow

Pipe Height: **8.4** (in.) Rod and Bar (Angled)  
Pipe Material: **Clay** ☐ Pipe Lined  
Invert Depth: **9.65** (ft.) Flow Characteristics: **Slow**  
Deposits: ☒ None ☐ Mud ☐ Sludge ☐ Debris ☐ Grease  
Silt Depth: **0** (in.) Deposits Extent:  
Infiltration: **None** Pipe Seal Cond: **Sound**
